## Air Quality Monitoring Report Across Selected Indoor and Outdoor Locations in Wandsworth Council, London

This report presents the findings of the Comprehensive Air Quality Monitoring Report Across Selected Indoor and Outdoor Locations in Wandsworth Council, London. The purpose of the monitoring was to assess indoor and outdoor air quality conditions across different public, educational, residential, commercial, and workplace environments, with emphasis on pollutant levels, ventilation performance, comfort conditions, and practical opportunities for improvement.

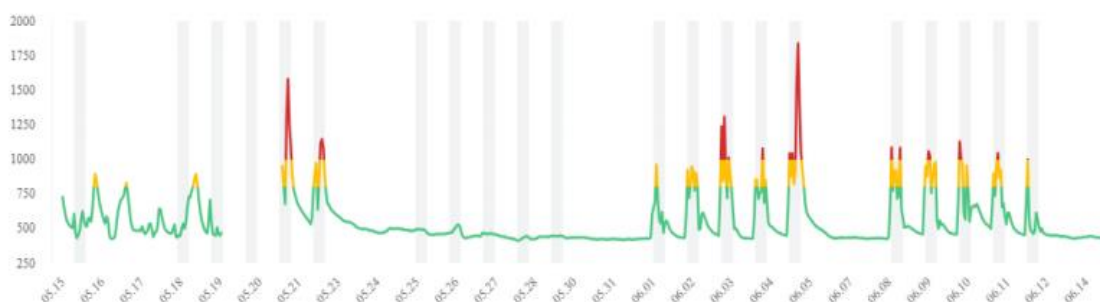
**Figure 1: CO<sub>2</sub> Air Quality details**

Graph shows aggregated hourly averages of all spaces in the building. Gray field marks opening hours.

Hurlingham School was monitored as an educational environment located at 122 Putney Bridge Road, London SW15. The indoor air quality report covered the period from 15 May 2026 to 14 June 2026. The building was classified as a school with balanced ventilation, two floors, and weekday opening hours from 9:00 AM to 5:00 PM. The monitoring was carried out using Airthings devices, including Space CO and Space Plus configurations, with measurements taken in key areas such as the classroom, corridor, canteen, and office.

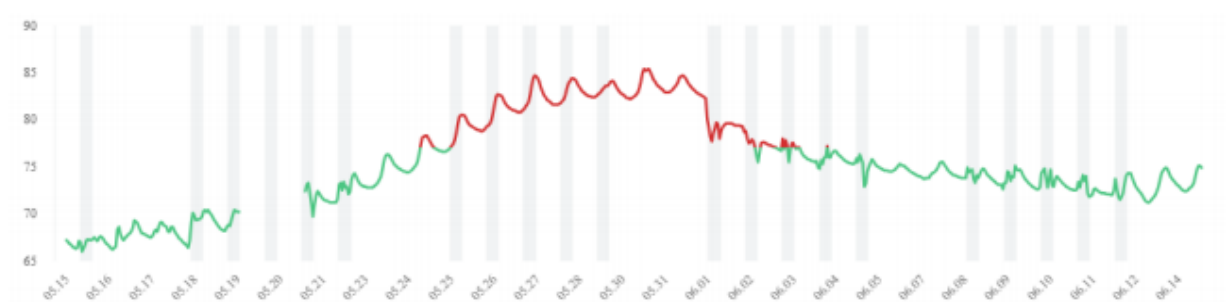
Graph shows aggregated hourly averages of all spaces in the building. Gray field marks opening hours.

| Floor | Space name | Average | Lowest | Highest |
| 0 | Canteen | 75.1 °F<br>Good | 65.4 °F<br>Good | 82.7 °F<br>Poor |

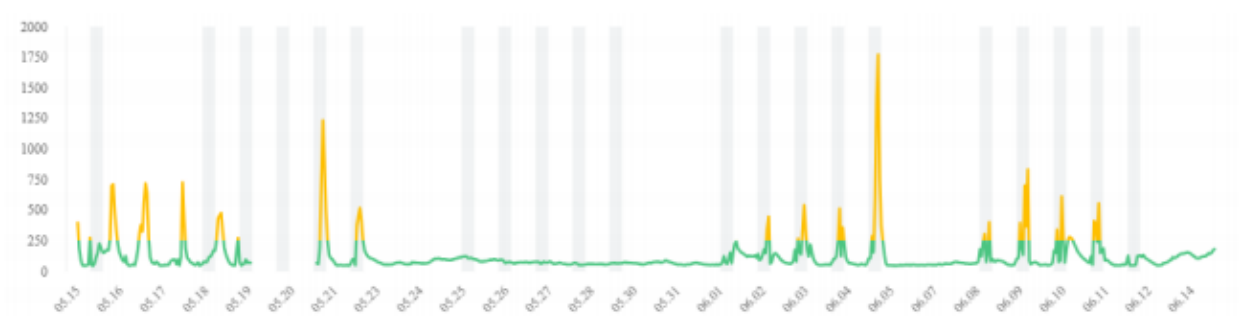
Graph shows aggregated hourly averages of all spaces in the building. Gray field marks opening hours.

| Floor | Space name | Average | Lowest | Highest |
| 0 | Canteen* | - | - | - |

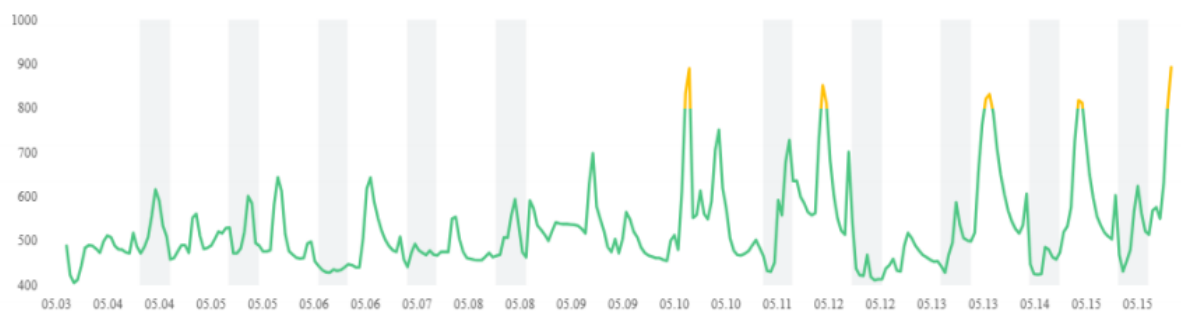
**Figure 6: Putney High Street CO2 and air quality details**

Graph shows aggregated hourly averages of all spaces in the building. Gray field marks opening hours.

The monitoring period covered 3 May 2026 to 15 May 2026, with readings interpreted during the stated opening hours of 9:00 AM to 5:00 PM, Monday to Friday. Airthings monitoring devices were used, including Space CO and Space Plus configurations. The available parameters in the report include CO2, temperature, and humidity, with a separate virus risk indicator report. The opening hour average CO2 level was 492 ppm, rated good, while the overall average value was 519 ppm, also good. No spaces recorded overall poor or occasional poor CO2 levels. This suggests that, during the monitored period, air dilution and ventilation conditions were generally favourable, with no evidence of sustained CO2 build up.

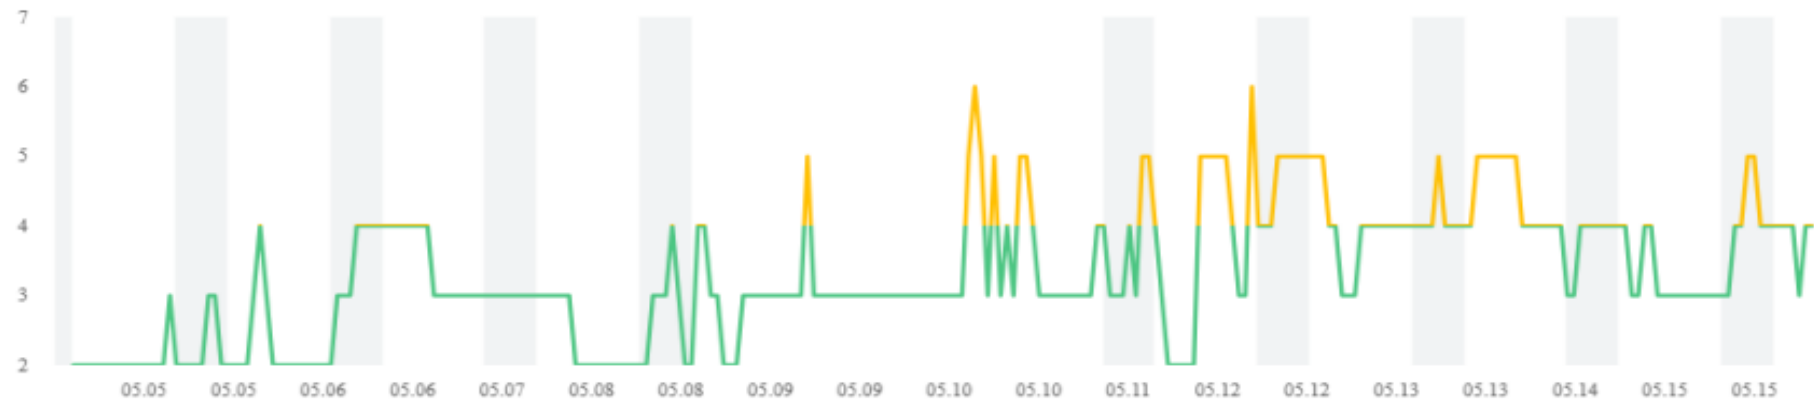
Figure 7: Virus risk indicator

The virus risk report showed one device above the recommended action level, with one monitored point averaging 4/10 and another averaging 3/10. This indicates low to moderate airborne transmission risk, with ventilation and occupancy still relevant. Recommendations include repeating monitoring with outdoor capable sensors for PM2.5, PM10, NO2, and ozone, separating rush hour patterns from general daytime averages, and using the findings to support traffic reduction, anti idling controls, improved pedestrian exposure management, and urban greening interventions.

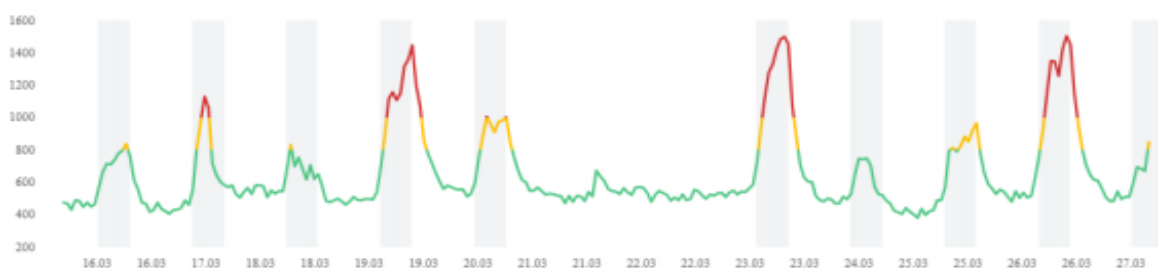
Graph shows aggregated hourly averages of all spaces in the building. Gray field marks opening hours.

| Floor | Space name | Average | Lowest | Highest |
| 1 | Space Pro | 889 ppm<br>Fair | 454 ppm<br>Good | 1575 ppm<br>Poor |

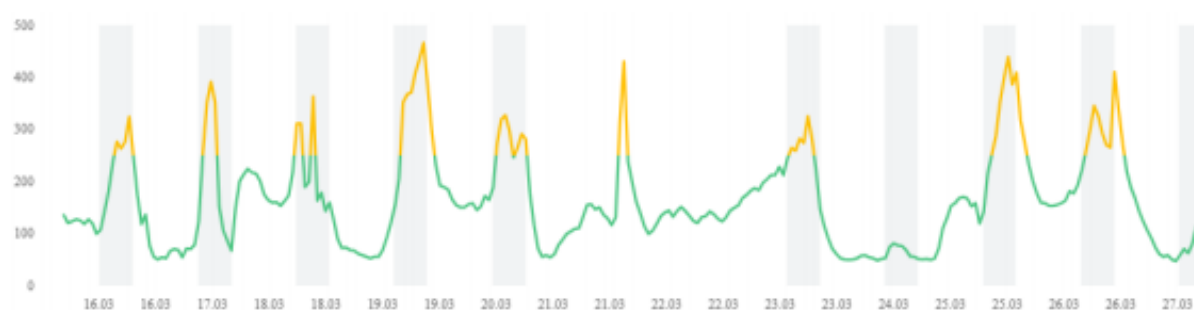
**Figure 10: River Homes VOC Air Quality details**

Graph shows aggregated hourly averages of all spaces in the building. Gray field marks opening hours.

| Floor | Space name | Average | Lowest | Highest |
|---|---|---|---|---|
| 1 | Space Pro | 238 ppb<br>Good | 46 ppb<br>Good | 1264 ppb<br>Fair |

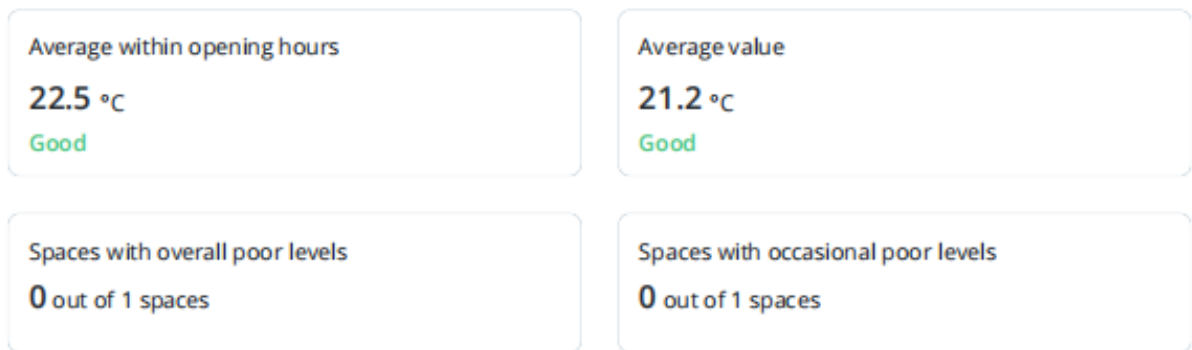
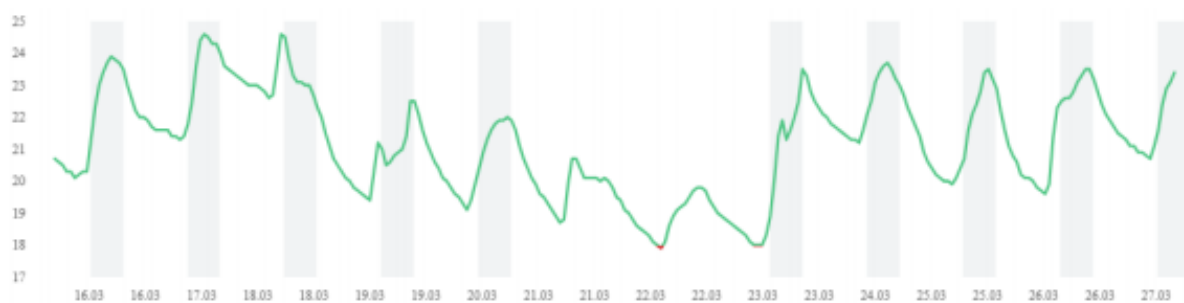
**Figure 11: Temperature and Humidity Air Quality details**

Graph shows aggregated hourly averages of all spaces in the building. Gray field marks opening hours.

| Floor | Space name | Average | Lowest | Highest |
|---|---|---|---|---|
| 1 | Space Pro | 22.5 °C<br>Good | 18.6 °C<br>Good | 24.7 °C<br>Good |

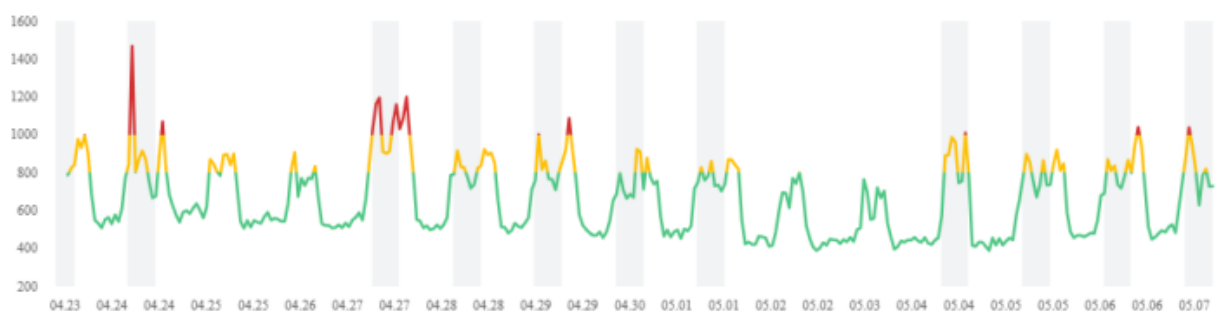
Graph shows aggregated hourly averages of all spaces in the building. Gray field marks opening hours.

| Floor | Space name | Average | Lowest | Highest |
| 2 | Space Pro | 832 ppm<br>Fair | 438 ppm<br>Good | 3773 ppm<br>Poor |

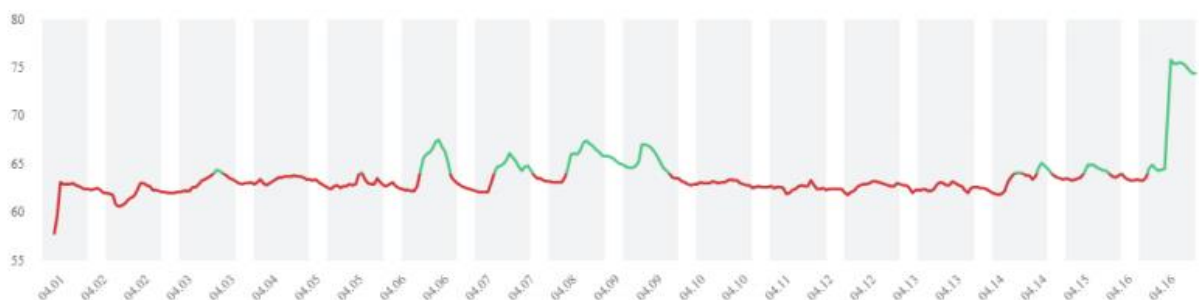
**Figure 21: Shaw Building Temperature Air Quality details**

Graph shows aggregated hourly averages of all spaces in the building. Gray field marks opening hours.

The strongest concern was temperature. The opening hour average was 63.8°F, rated poor, with one of two spaces showing overall poor temperature levels and both spaces showing occasional poor levels. This indicates that the building may have been too cool during parts of the monitoring period. In a hostel setting, low temperature can affect comfort, sleep quality, study conditions, and general wellbeing. Unlike short stay spaces, residential accommodation requires consistently comfortable conditions because exposure is longer and more personal.

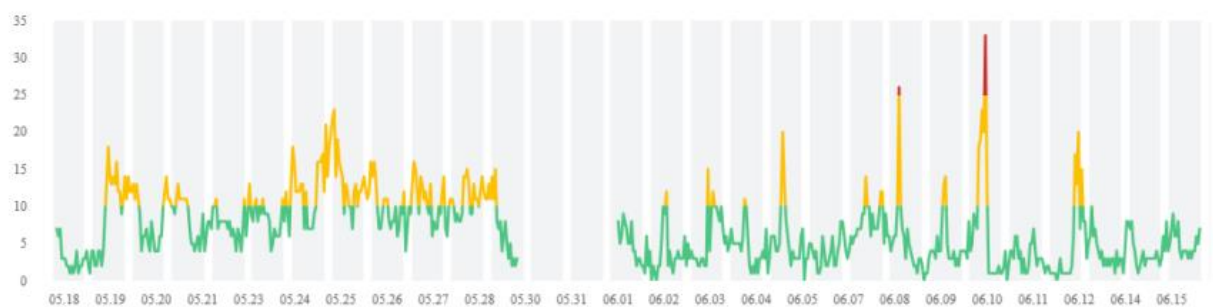
**Figure 27: Southland Reef PM 1.0 Air Quality details**

Graph shows aggregated hourly averages of all spaces in the building. Gray field marks opening hours.

However, the report adds an important nuance to the previous interpretation. Although average PM<sub>2.5</sub> and PM<sub>1</sub> levels were good, both indicators recorded occasional poor peaks, with PM<sub>2.5</sub> reaching 79  $\mu\text{g}/\text{m}^3$  and PM<sub>1</sub> reaching 71  $\mu\text{g}/\text{m}^3$ . This suggests short term particle events, possibly linked to outdoor infiltration, occupant movement, cleaning, food related activity, or local activity peaks. VOC levels remained good on average, although the highest VOC value reached a fair level, indicating occasional but not persistent chemical emission events.
